CONDITION SURVEY FOR INSURANCE

Name of vessel	Name deleted
Hull identification number	BEYUSxxxJ292/xxx
Registered port	Toronto
Registered number	Not seen
Description	Beneteau Oceanis 440, Moorings 445 fiberglass aux diesel sloop, built in October 1992
Person requesting the survey	XXX XXXXXX.
Persons present at survey	XXX XXXXXX and XXX XXXX, liability attaches to no third party.
Purpose of Survey	Condition for purchase
Date of Survey	9 th July 2005
Date of report	10 th July 2005
In water location	Nanny Cay and the Sir Francis Drake Channel, Tortola, British Virgin Islands
Out of water location	Nanny Cay Yard, Tortola, British Virgin Islands
Mast Surveyed Aloft	Yes, the starboard fore lower swage is cracked aloft and should be replaced, no other defects seen.
Estimated Value	Approximately \$120,000.00, see the last page of the report.
Estimated Replacement Value	Approximately \$250,000.00

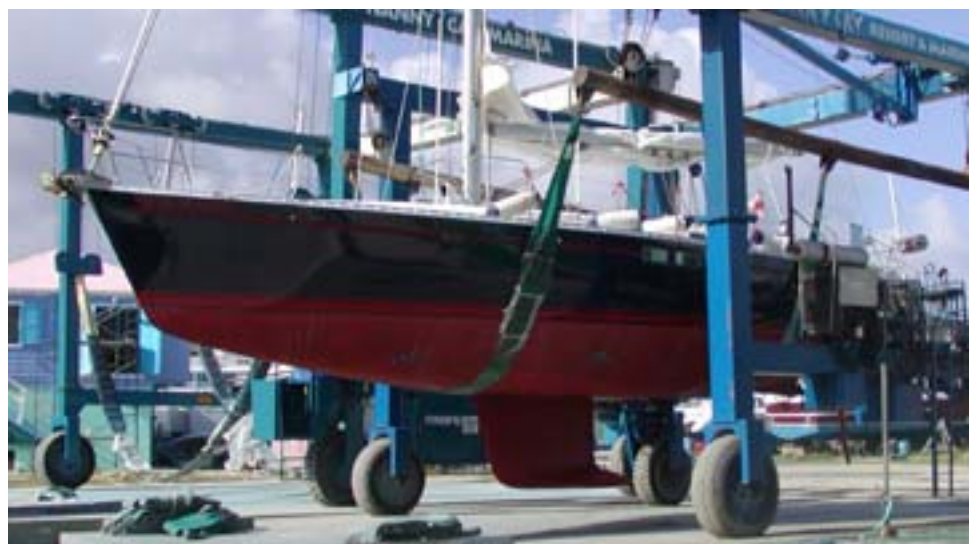
GENERAL COMMENTS: The structural liner to the fore and aft areas of the vessel appear to be detached from the hull in various places, probably as a result of a hard grounding. The grid is also cracked in the region of the aft end of the keel. The buyer intends to use the vessel for offshore sailing and the dis-bonding is likely to result in structural problems when sailed offshore. We therefore do not recommend this vessel as suitable for the intended purpose without substantial repairs. There was no removal of fittings or furnishings.
