CONDITION SURVEY FOR INSURANCE

Name of vessel	Name deleted
Hull identification number	BEYUSxxxJ292/xxx
Registered port	Toronto
Registered number	Not seen
Description	Beneteau Oceanis 440, Moorings 445 fiberglass aux diesel sloop, built in October 1992
Person requesting the survey	XXX XXXXXX.
Persons present at survey	XXX XXXXXX and XXX XXXX, liability attaches to no third party.
Purpose of Survey	Condition for purchase
Date of Survey	9 th July 2005
Date of report	10 th July 2005
In water location	Nanny Cay and the Sir Francis Drake Channel, Tortola, British Virgin Islands
Out of water location	Nanny Cay Yard, Tortola, British Virgin Islands
Mast Surveyed Aloft	Yes, the starboard fore lower swage is cracked aloft and should be replaced, no other defects seen.
Estimated Value	Approximately \$120,000.00, see the last page of the report.
Estimated Replacement Value	Approximately \$250,000.00

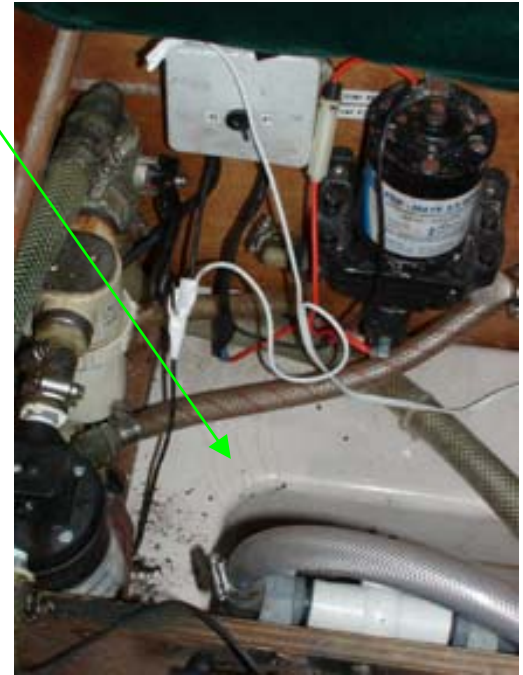
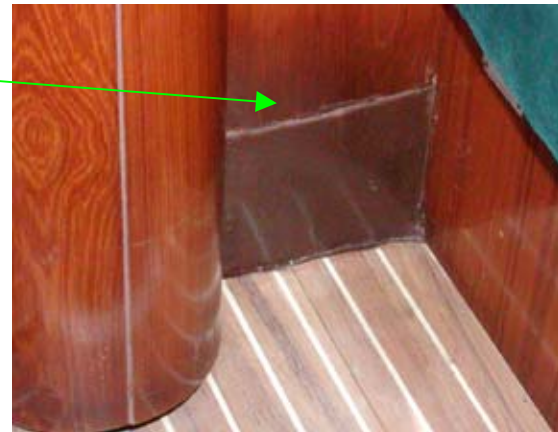
Plywood with veneers and Formica, The cabinet work under the showers is discoloured. The cabinet work next to the mast base is discoloured. The partition to the port side, under the fore berth, aft of the water tank, is rotten and should be replaced. The cabinet work has been slightly displaced at the galley / main bulkhead area. The door to the fore cabin would not close when underway on starboard tack. There is movement at the galley worktop to main bulkhead area
